AN INVESTIGATION OF THE  
S/N FATIGUE LIFE GAGE

DAVID H. JOHNSON

SUBMITTED IN PARTIAL FULFILLMENT OF THE  
REQUIREMENTS FOR THE DEGREES OF  
MASTER OF SCIENCE  
AND  
NAVAL ENGINEER

at the  
MASSACHUSETTS INSTITUTE OF TECHNOLOGY  
June 1967

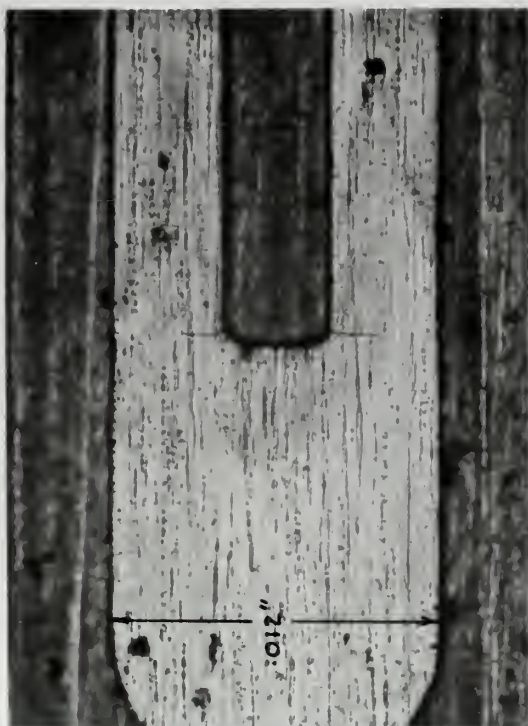
- XIII      CRACKING IN STRANDS OF EA STRAIN GAGE (100X)
- XIV      CRACKING IN STRANDS OF EA STRAIN GAGE SHOWN  
IN FIGURE XIII (200X)
- XV        DIAGONAL CROSS SECTION OF S/N FATIGUE GAGE -  
ZERO CYCLES (100X)

The strain level of this test was  $\pm 3157\mu\epsilon$  for reverse bending. When the test was stopped at 6000 cycles, a definite but small zero shift in gage resistance was noticed. At 10,000 cycles the resistance had increased even more, but was still quite small; however, between 10,000 cycles and 15,250 cycles a sharp increase occurred in gage resistance. At this point the EA strain gage was studied with a metallograph. Cracks were observed in every strand as pictured in Figure XIII and Figure XIV. Figure XIII was photographed at 100X, and Figure XIV is the same field of interest at 200X. The mean crack length at the

tip end was .00116 inch and at the base end was .00196 inch. The maximum crack length was .00315 inch or 78.8% of the width of that strand. Every crack propagated from the same area as noted in Figures XIII and XIV. It appears that the cracks are caused by stress concentrations. Since the gage was not studied at the inception of zero shift, this test did not determine whether or not cracks had developed when the zero shift occurred. Using the criteria that a strain gage is near the end of its life when zero shift occurs (29), the EA gage should not be used after 6000 cycles in this case.

Two points are brought out by the crack observations. First, if a crack occurs, it will occur in the same area as noted in Figures XIII and XIV. Second, the mechanism causing small changes in resistance (i.e. 1% - 2%) of a foil gage can be attributed to cracking and not just work

After studying the results from Tests # 2, # 3 and # 5, the fatigue gages were inspected for cracks. If cracks had developed, these cracks should occur in the areas of stress concentration as seen in Figures XIII and XIV for the EA strain gage. Specimen L-3, which showed excellent gage performance correlation (Figure IX), was examined first. A significant crack was found as expected in one of the places of high stress concentration (i.e. the same area as in the EA strain gage). This crack was located at the base end of the third strand, numbering from the outer most strand. At the very outside edge of the strand, the crack had opened approximately 2 - 3 mils. In one portion of the strand adjacent to the crack, a very small void had been created. It is unfortunate that in the process of polishing for a clear photograph at 1000X this area of interest was lost; however, after polishing the area to a depth of  $9.84 \times 10^{-4}$  inch, Figure XX was obtained at 1000X\*. The average strand thickness is 2 mils which can be used as a scale in the photograph. If this crack had been viewed looking down at the strand, the actual reduction

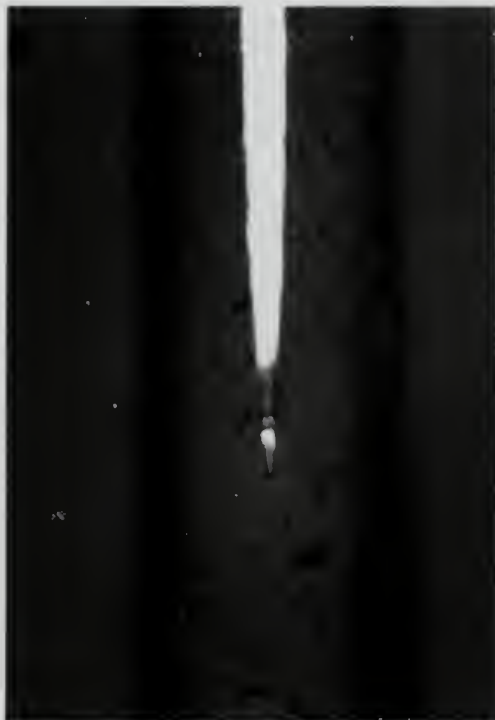
FIGURE XVI

<u>FIGURE</u>		<u>Page</u>
XVI	DIAGONAL CROSS SECTION OF S/N FATIGUE GAGE - LEFT SIDE OF CENTER STRAND IN FIGURE XV (465X)	36
XVII	DIAGONAL CROSS SECTION OF S/N FATIGUE GAGE TURRET - ZERO CYCLES (100X)	37
XVIII	DIAGONAL CROSS SECTION OF S/N FATIGUE GAGE TURRET - SAME VIEW AS FIGURE XVII (100X)	37
XIX	LONGITUDINAL CROSS SECTION OF S/N FATIGUE GAGE TURRET - SPECIMEN L-2, AFTER 10,690 CYCLES AND TERMINAL WIRE REMOVED (100X)	37
XX	LONGITUDINAL CROSS SECTION OF S/N FATIGUE GAGE STRAND AFTER POLISHING TO DEPTH OF $9.84 \times 10^{-4}$ INCH - CRACK ROOT OF SPECIMEN L-3 AFTER 4020 CYCLES (1000X)	37
XXI	LONGITUDINAL CROSS SECTION OF S/N FATIGUE GAGE AFTER SLIGHT POLISHING OF STRAND AT OUTER EXTREMITY - SPECIMEN L-1 AFTER 49,528 CYCLES (1000X)	38
XXII	LONGITUDINAL CROSS SECTION OF S/N FATIGUE GAGE AFTER SLIGHT POLISHING OF STRAND AT OUTER EXTREMITY AND NEAR INSIDE RADIUS AT END OF STRAND - SPECIMEN L-2 AFTER 10,690 CYCLES (1000X)	38

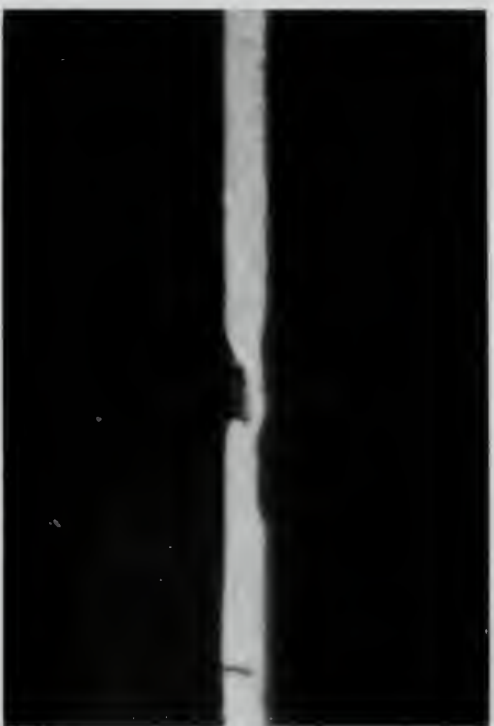
FIGURE XX

- XX        LONGITUDINAL CROSS SECTION OF S/N FATIGUE GAGE  
STRAND AFTER POLISHING TO DEPTH OF  $9.84 \times 10^{-4}$   
INCH - CRACK ROOT OF SPECIMEN L-3 AFTER 4020  
CYCLES (1000X)

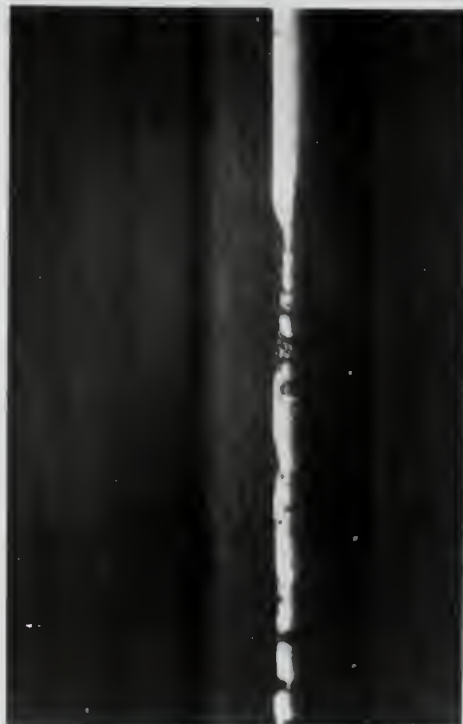
FIGURE XXIII

Figure XXIII taken at 500X, shows one of the areas of specimen L-5 where a crack might be expected to develop. The thick portion in the right of the photograph is the end of the strand, and the thin portion is the edge of a strand which is joining at the inside radius. Figure XXIV, taken at 500X, shows the same area after a very brief polishing (approximately .001 mm). The small cracks in these two photographs are probably notches due to etching and not really cracks. There are several pits in the strand which were never noticed in a gage which had not been fatigued. The reason for these pits is unknown, although it is possible that the pits are caused by work hardening.

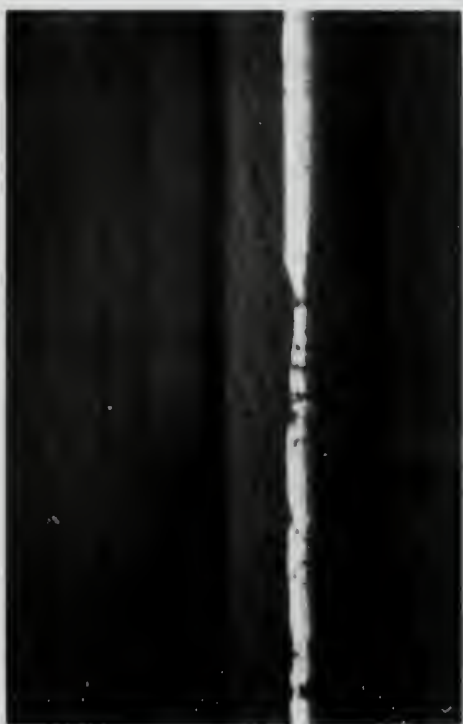
FIGURE XXIV

- XXIV LONGITUDINAL CROSS SECTION OF S/N FATIGUE GAGE -  
SAME VIEW AS FIGURE XXIII AFTER SLIGHT, ADDITIONAL  
POLISHING (500X)
- XXV LONGITUDINAL CROSS SECTION OF S/N FATIGUE GAGE  
TURRET, VOID AT TURRET-STRAND - EPOXY INTERFACE -  
SPECIMEN L-5 AFTER 550,000 CYCLES (100X)
- XXVI LONGITUDINAL CROSS SECTION OF S/N FATIGUE GAGE  
TURRET - SAME POINT OF INTEREST IN FIGURE XXV  
(200X)
- XXVII S/N FATIGUE GAGE, TYPE NA-01
- XXVIII STRAIN GAGE AND FATIGUE GAGE MOUNTED ON TOP OF  
SPECIMEN A-3

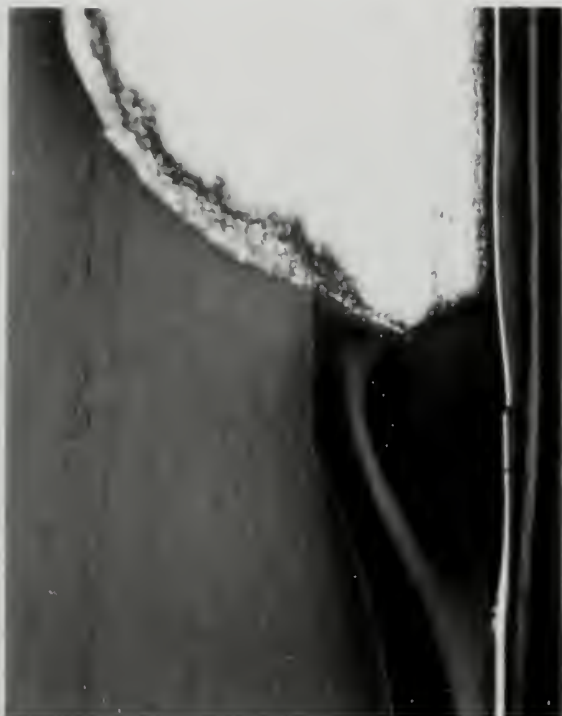
FIGURE XXVI

to the turret helped contribute to this phenomena. The void is shown in Figure XXV at 100X and Figure XXVI at 200X. The photographs show a crack in the foil grid below the void. The crack could have developed during polishing because the foil was not rigidly constrained at that point. The cause for the crack cannot be readily ascertained, but the crack is long enough that it could not be polished out. It probably extended across the void. A combination of the crack and possible non-rigidity of the turret to the foil could have caused a rapid increase of  $\Delta R$ .

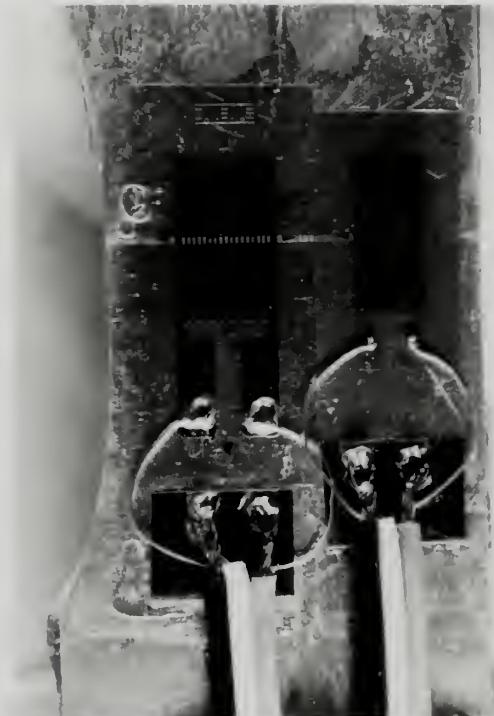
FIGURE XXVIII

There is indication that voids in the epoxy, adjacent to the turrets and voids in the lead turrets may cause deviation from the predicted performance curves at higher cycles of fatigue. Cracking of the foil grid may also be a possibility contributing to this deviation, if the cracking occurs erratically. No cracking occurred in any of the terminal hook up wires in this investigation. Figures XXVIII and XXX show the type of hook up used and was very successful.

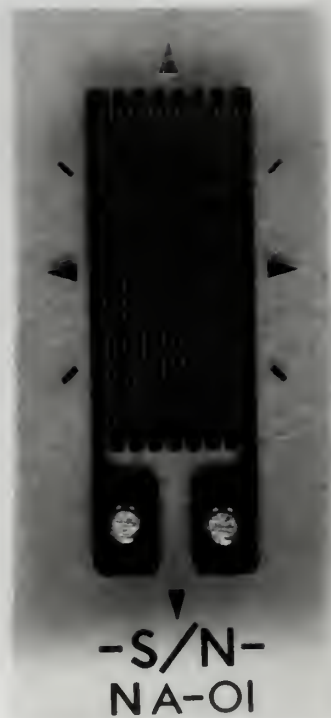
FIGURE XXVII

The recognition of material failures by a mechanism called fatigue\* is by no means new to the twentieth century (2); however, the development of sensor devices to predict fatigue failure is rather recent. Fatigue sensor devices date back to about 1948 (15), and today at least two companies market these devices. One such device is THE S/N\*\* FATIGUE LIFE GAGE which was developed by Harting (15) (16). The fatigue gage is manufactured by Micro-Measurements, Inc. and is marketed by W. T. Bean, Inc. This investigation is confined to the particular gage shown in Figure XXVII, Section V. A description of the gage can be found in Appendix C.
